DOI 10.15826/rjcsst.2021.2.003

QUALITY ASSESSMENT OF RETAILABLE AND MODULAR BUILDINGS SUBJECT TO DIFFERENT OPERATING CONDITIONS

ОЦЕНКА КАЧЕСТВА БЫСТРОВЗВОДИМЫХ И МОДУЛЬНЫХ ЗДАНИЙ, ПОДВЕРЖЕННЫХ РАЗЛИЧНЫМ УСЛОВИЯМ ЭКСПЛУАТАЦИИ

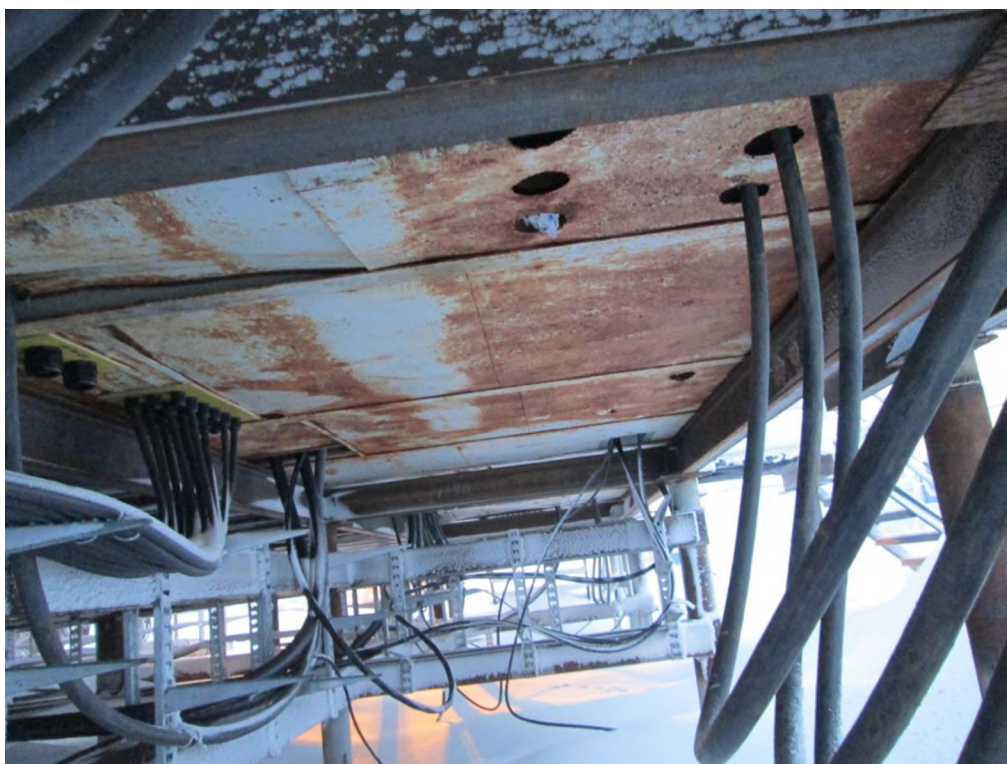
Defects in the structure of the lower supporting frame are violation of the anti-corrosion coating and surface corrosion (pitting and local) steel on an area of 10...100 % of the total surface area, as well as local pitting corrosion of steel

Defects of coating panels and walls are violation of anticorrosive coating and surface corrosion (pitting and local) of steel on an area of 0.5...100% of the total surface area.

Violation of the heat-insulating floor layer is up to 50%.

Destruction of mineral wool insulation from low temperatures is to 50%.

Fig. 2. Corrosion destruction field of object 2

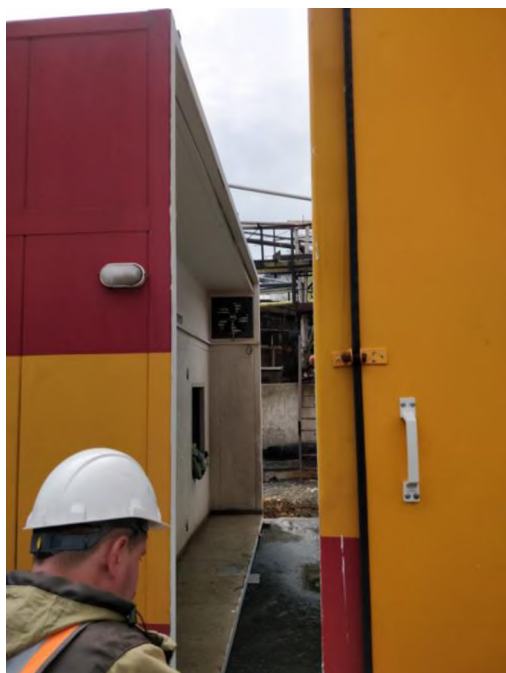
3 container-type blocks were delivered to the construction site for the purpose of subsequent installation. They were exhibited without sealing close to the design position (Fig. 3). Due to the fact that at this time the foundation was being installed, the blocks spent a month under the influence of sulfuric acid vapors in the pumping station in a leaky state.

Fig. 3. Storage conditions for prefabricated parts

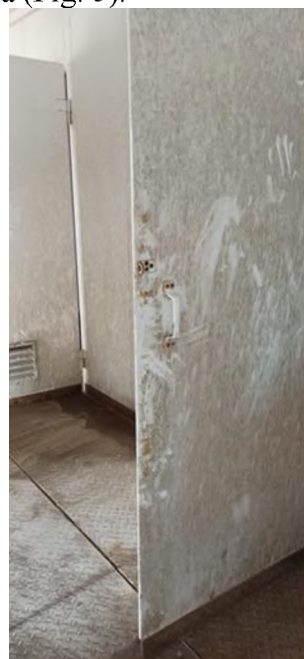
Corrosion of the inner surface of containers: doors, floors, walls from 10 to 100% of the surface (Fig. 4).

Fig. 4. Corrosion of paint coating of doors and walls

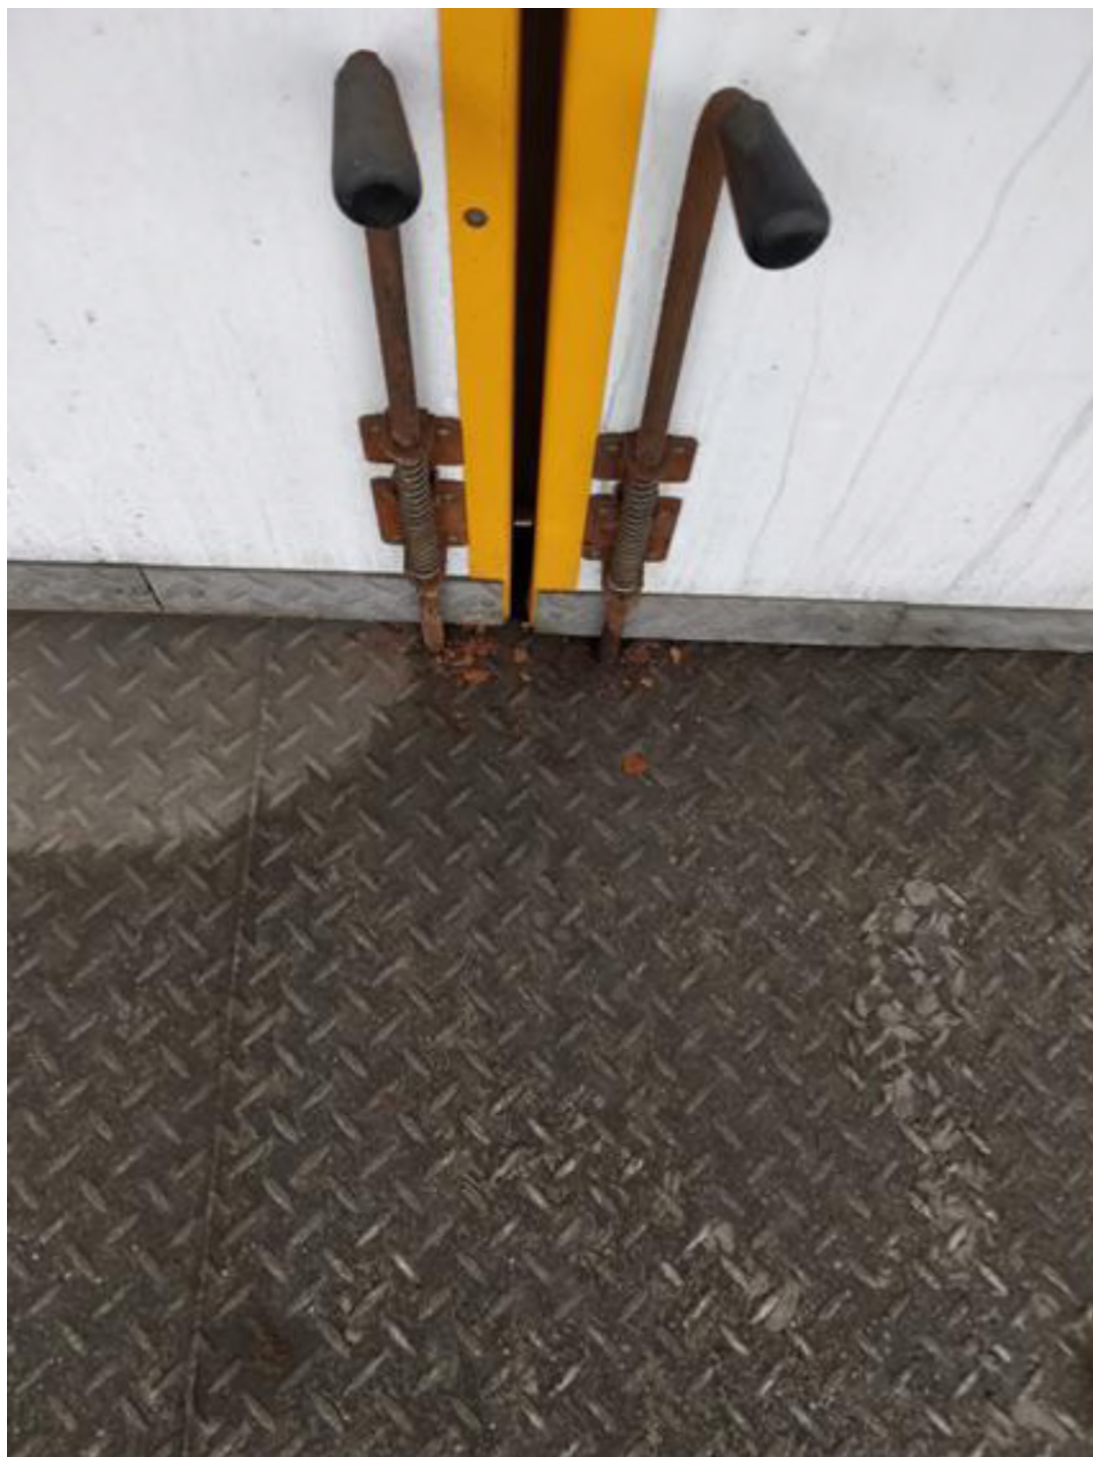
Corrosion of all metal fasteners and equipment locks inside the blocks up to 100% of the area (Fig. 5).

Fig. 5. Corrosion of internal fittings
